# **Loudoun County Department of Fire, Rescue, and Emergency Management**

## **SIGNIFICANT INJURY INVESTIGATIVE REPORT 43238 MEADOWOOD COURT MAY 25, 2008**

**September 2008**

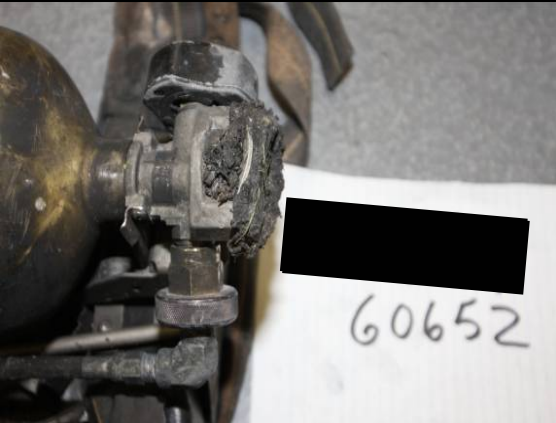
| Cylinder has signs of exposure to high heat or flame. | Bumper distorted and pushed down into gauge assembly. Front side of gauge lens not visible, covered by damaged bumper. There appears to be a hole in the gauge lens. |

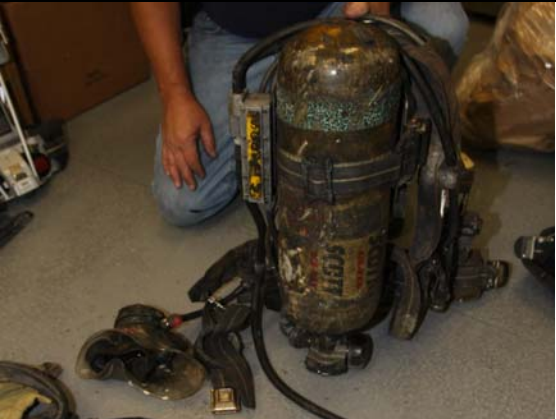
| The back side of the lens has no apparent damage; gauge is visible and showing 2000 psi. Gauge needle is not accurate, needle of gauge stuck due to front side damage. Actual air in cylinder is zero. Hand wheel is missing paint. Hydrostatic test label significantly damaged, date is slightly visible. | Green stripe around the top portion of cylinder blistered. |

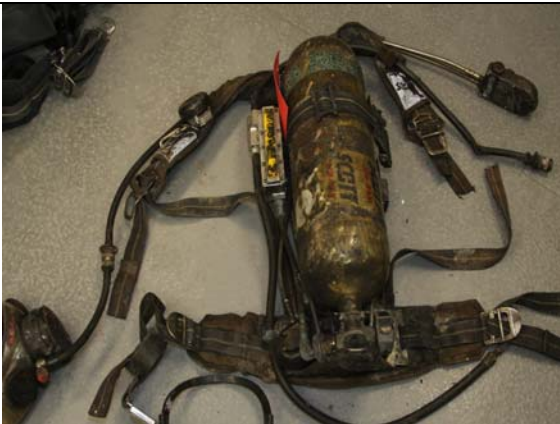
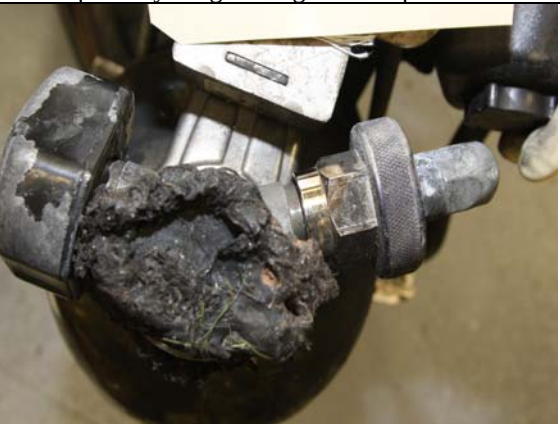
| High pressure connection still connected to cylinder. The coupling nut assembly appears to have a shiny brass look, possibly a sign of high heat exposure. | |

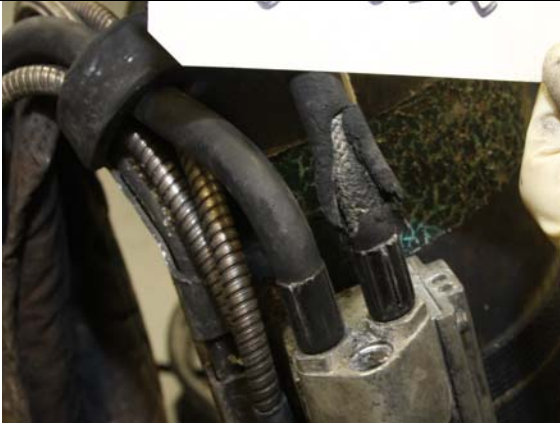
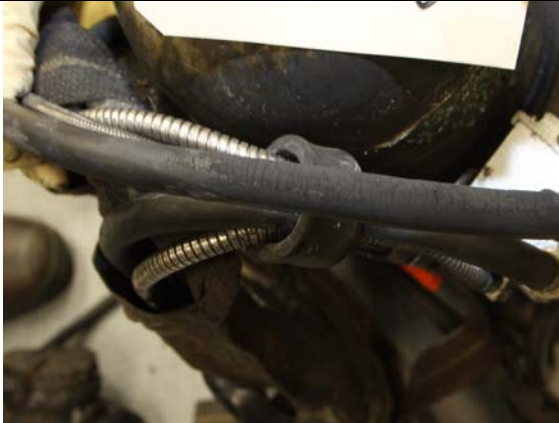
| <p>EBSS hose has a tear in the outer cover at the reducer, some damage to inner weave.</p> | <p>The top portion of the EBSS hose where it would curve at the top portion of the cylinder appears to have heat damage.</p> |

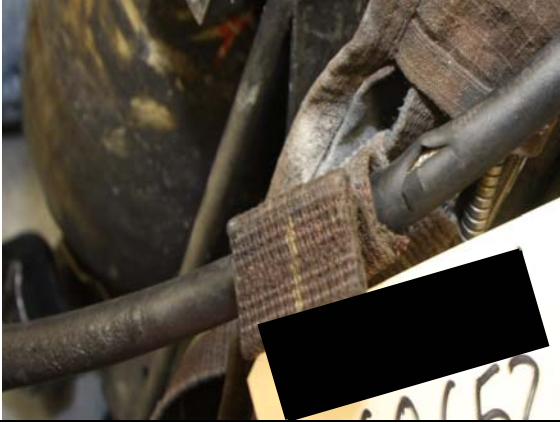
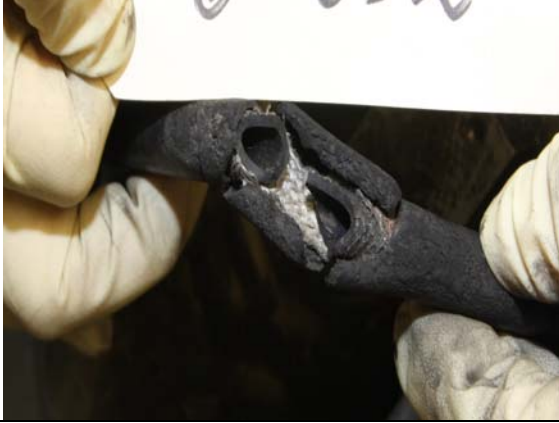
| <p>There is a tear on the outer cover adjacent to where it is in position next to the cylinder retaining strap.</p> | <p>Appears the hose was cut just below the EBSS retaining strap. Quick connect coupling looks ok, boot is missing.</p> |

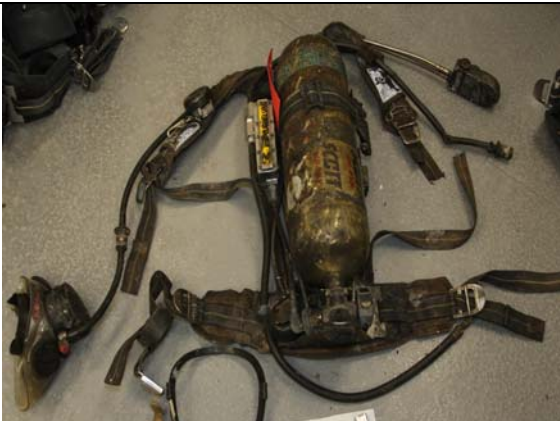
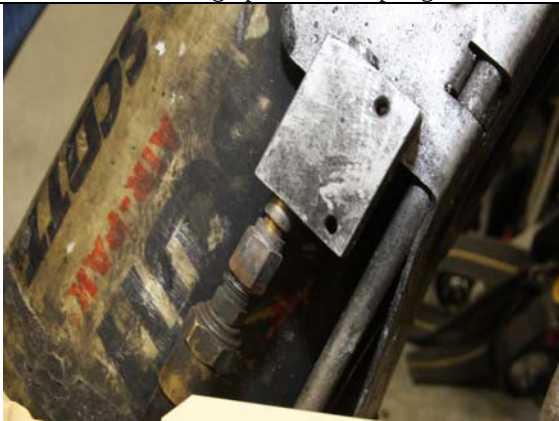
| <p>This SCBA also has a supplied air hose connected to the bottom side of air manifold.</p> | <p>Hose was loose, not secured into catch that holds the coupling. The loose end is a Schrader connection that has a brassy look as did the high pressure coupling nut.</p> |

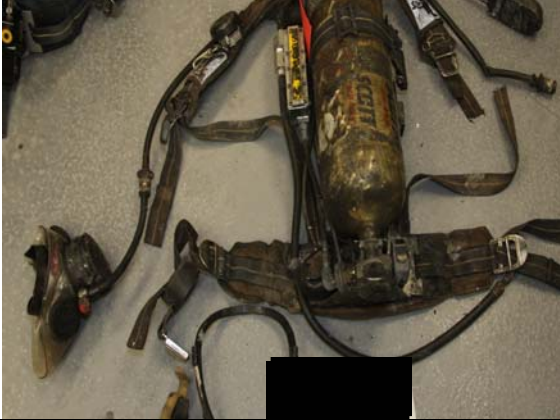
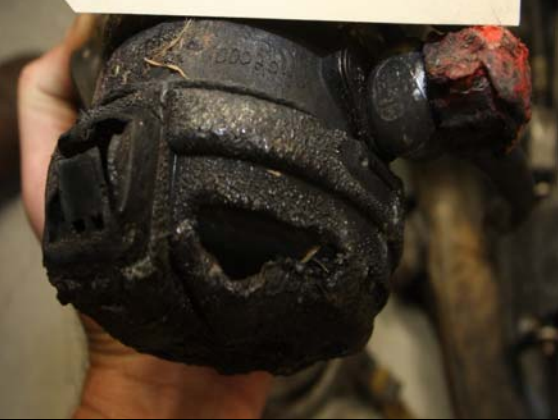
| <p><b>Regulator:</b></p> <p>The regulator appears to have been exposed to high heat. It was still attached to lens and the low pressure air line of the reducer.</p> | <p>The entire cover is distorted from exposure to high heat.</p> |

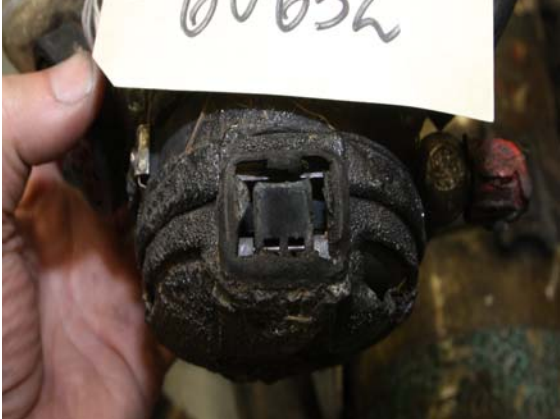
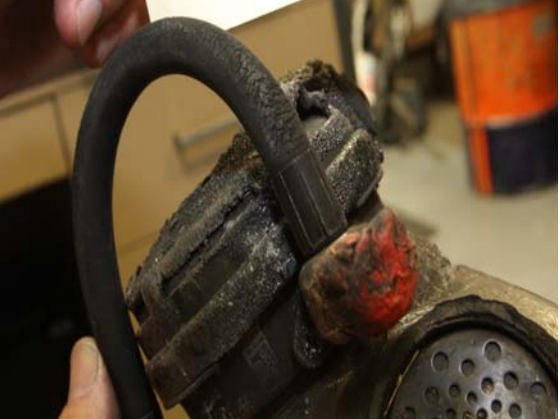
| <p>The top portion of the air saver boot is missing, exposing the inside of the regulator cover and air saver switch mechanism.</p> | <p>The purge knob is significantly distorted, still turns as designed.</p> |

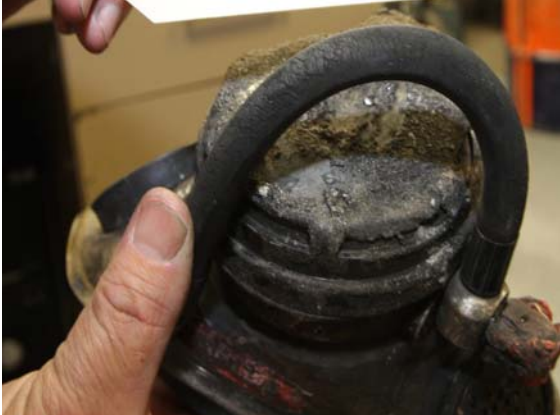
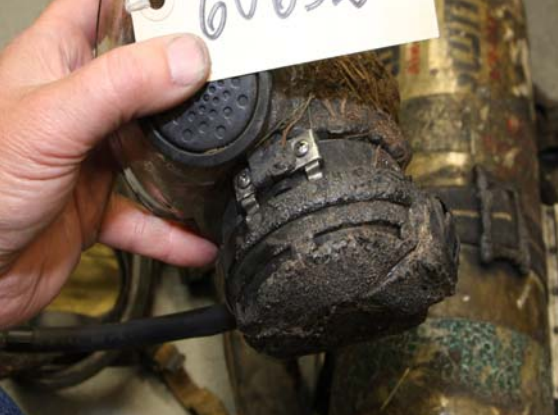
| <p>The outer cover of hose cracked, no separations.</p> | <p>The latch is not operational, is stuck to the lens.</p> |

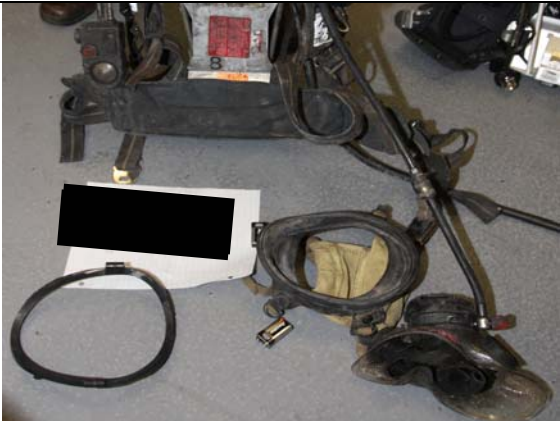
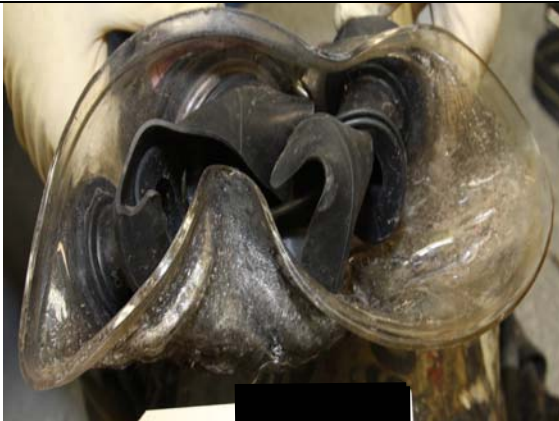
| <p><b>Mask:</b></p> <p>Mask was not intact. The lens was separated from the upper and lower bezel. The upper and lower bezels were attached to each other but separated from the face seal. Face seal and harness still intact together.</p> | <p>The mask is an AV3000 size medium face seal. The lens was grossly disfigured from high heat or flame exposure. Appears grass was embedded into the front of the lens. The nose cup, both voicemitter ducts with inhalation valves surrounded by the melted deformed lens.</p> |

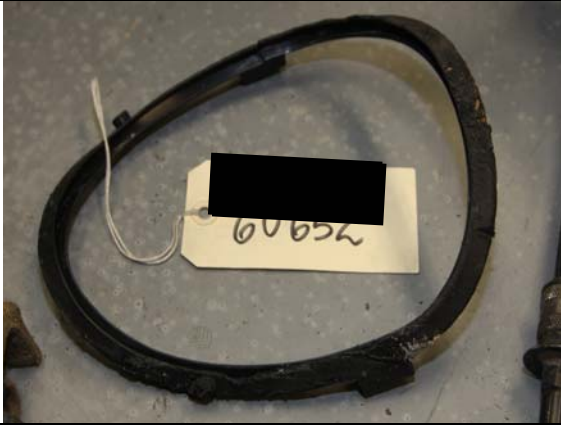
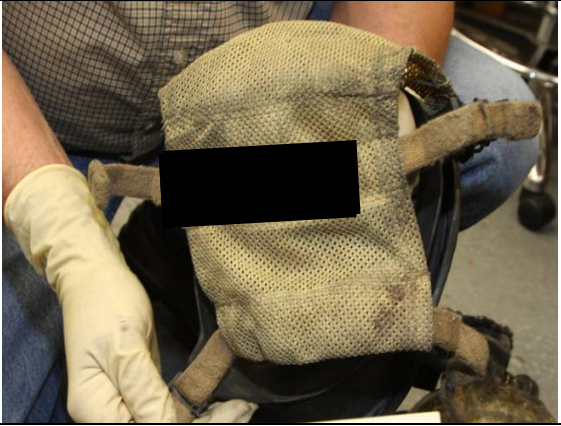
| <p>Outer portion of voicemitters show some signs of heat exposure. Upper and lower bezels showed signs of heat damage on the front surfaces, mostly to the top right and bottom left.</p> | <p>The harness and both neck and temple straps look good, no apparent damage. All 4 size dots present both buckle pads in place.</p> |

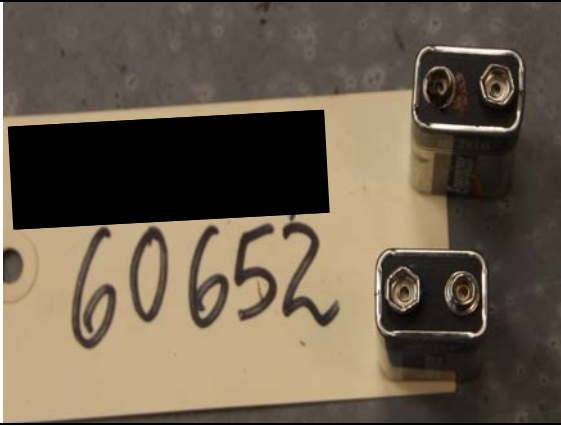
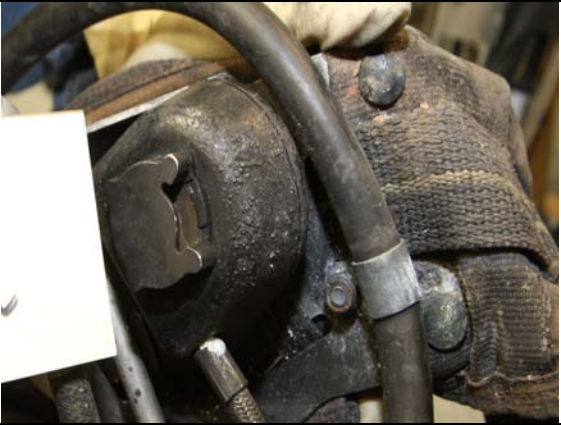
| <p><b>P.A.S.S. / Console:</b></p> <p>Pak-alert was intact. Two energizer batteries were out of unit loose with the gear. One of the batteries showed significant corrosion damage on the positive terminal. The battery cover was missing 1 screw. Original batteries placed in pak-alert and did supply power to it allowing it to go into alarm when emergency button was activated.</p> | <p>Left side of housing showed signs of heat exposure.</p> |

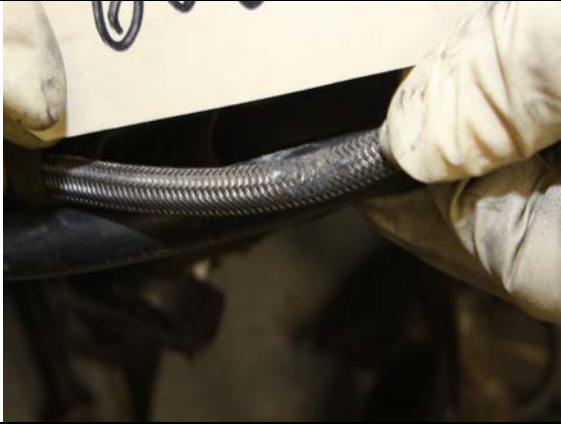
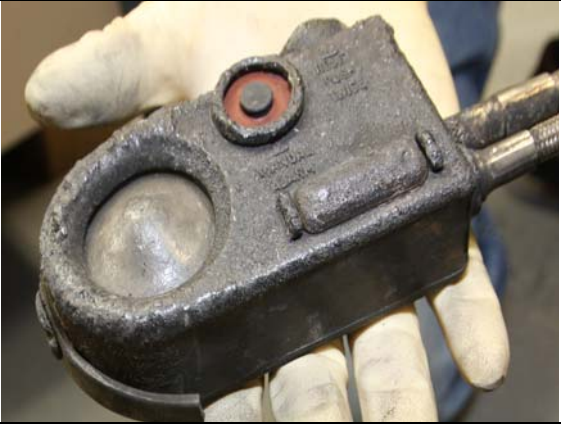
| <p>Wire enclosure going to console in good shape, some debris melted on top portion of it where it curves down near the top of the cylinder.</p> | <p>The console showed signs of high heat exposure. Gauge lens was distorted, gauge not visible. Cover for indicator lights distorted.</p> |

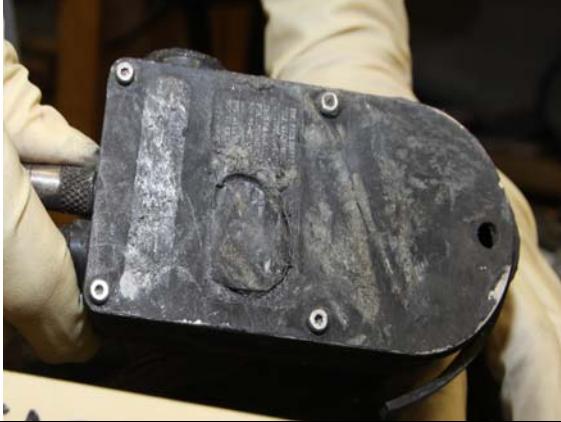
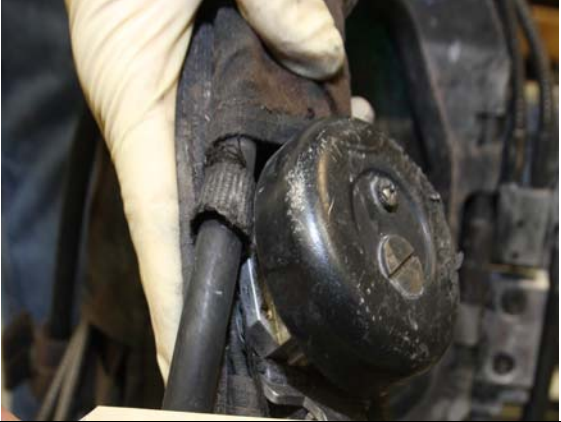
| <p>The red and yellow on the emergency and reset buttons visible, some smoke stain. Gauge retaining strap was cut. Gasket appears intact, back cover labels illegible from possible heat damage.</p> | <p>Bell assembly intact, retaining strap still connected to low pressure breathing hose. Cricket line is intact, no visible damage.</p> |
