# **Loudoun County Department of Fire, Rescue, and Emergency Management**

## **SIGNIFICANT INJURY INVESTIGATIVE REPORT 43238 MEADOWOOD COURT MAY 25, 2008**

**September 2008**

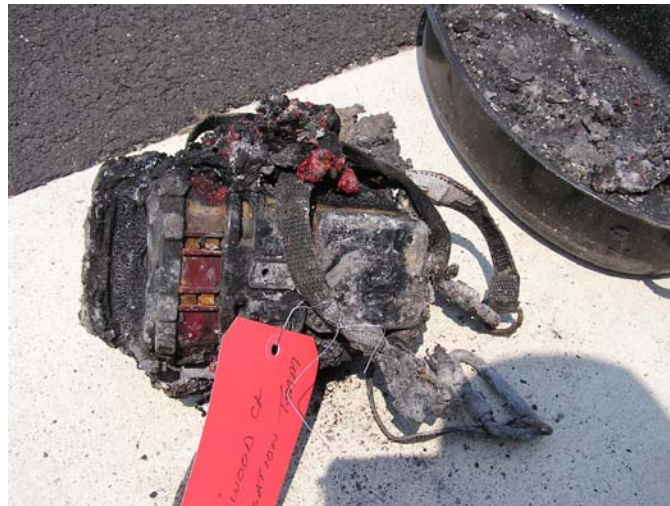
**Figure 25: Tower 6 TIC**

During the investigative process, the Team recovered the TIC in the Master Bedroom under a window on Side Delta (see Figure 25).

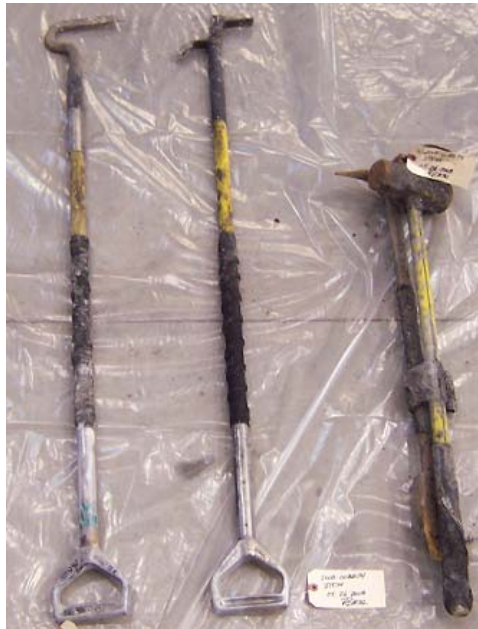
**Figure 26: Gear Photo 027**

Figure 26 illustrates the tools carried into the structure by the crews of Reserve Engine and Tower 6. In addition, all four personnel carried a flashlight. The flashlights were heavily damaged; the Tower Officer's flashlight lens had completely disintegrated.

**Left to Right: Equipment Carried by Tower Officer, Reserve Engine Officer, and Tower Firefighter**

In post-incident interviews the Tower Firefighter indicated that, in retrospect, the sledgehammer was not the most appropriate tool for a residential structure fire.

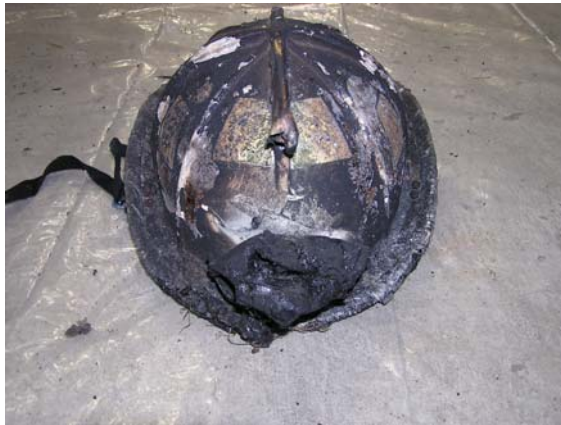
**Figure 28: Tower Officer**

- The specific damage noted to the trim with its complete deterioration, particularly on Tower Officer's protective coat and pants suggests exposure temperatures that were well in excess of 600° Fahrenheit for several seconds. The reflective marking damage combined with edge bead melting of helmet materials, bubbling and extension of eye shields on the protective helmets worn by the Reserve Engine Officer, Reserve Engine Firefighter and Tower Firefighter also confirm exposures at these levels. The damage to the helmets, hoods, and portions of the protective clothing, and other components worn by the firefighters do support the characterization of the firefighters being exposed to a flashover.

The following photos are included to illustrate the variations in heat exposure sustained by each of the injured firefighters.

**Recommendation: Modify gear specifications to relocate the reflective striping away from compression areas and require additional layers of thermal protection on the bunker coat sleeves.** For further discussion, see page 114, Additional Considerations.

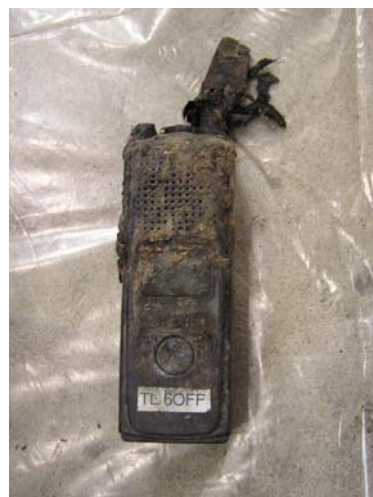
**Figure 38: Tower Officer Portable**

- The Tower Officer's radio was on 6-Charlie and was not on scan mode. The Officer carried the radio in a radio strap; both the portable radio and the radio strap sustained thermal damage (see Figure 38).
- The Reserve Engine Firefighter carried the portable in the radio pocket of the turnout coat. The portable was on 6-Charlie and was not on scan.
- The Tower Firefighter carried the radio in a radio strap. The portable was on 6-Delta and was not on scan. The Tower Firefighter's radio sustained thermal damage.

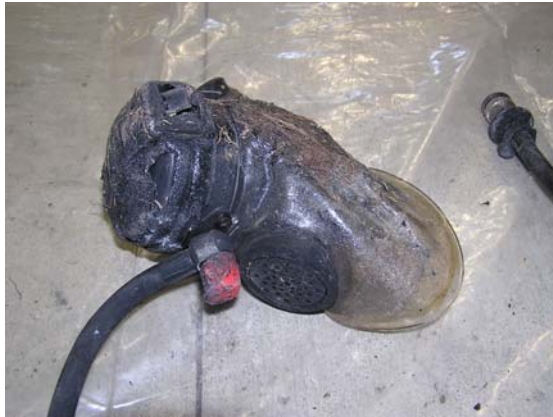
**Figure 39: Tower Officer**

- The Officer's SCBA regulator and facepiece were in such a condition that they were unable to be tested (Figure 39).
- There was significant damage to the facepiece; the lens was grossly disfigured from high heat or flame exposure.
- The regulator was still attached to the lens and the low pressure air line of the reducer.
- The entire cover was distorted from exposure to high heat.
- The latch was not operational.

- There was heat damage to various hoses and couplings as well as the backframe assembly and air cylinder. In particular, the Air Shop noted that the Officer's Emergency Breathing Support System (EBSS) hose had a tear in the outer cover, heat damage, and a cut just below its retaining strap.

The report concluded that due to the compromised EBSS line and extreme thermal damage to the regulator, the SCBA was only seconds from failure.

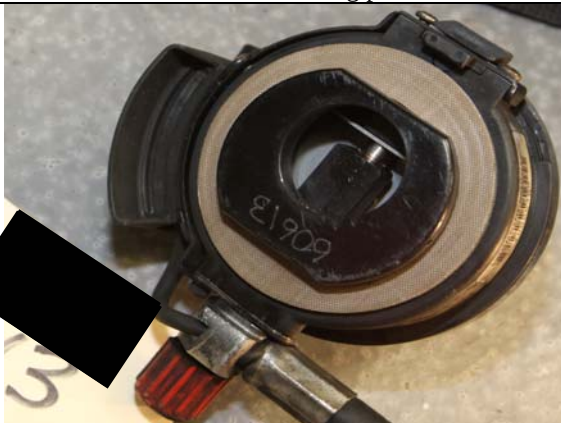
| <p>No visible damage to hose, purge knob is smoke stained with no visible damage, turns as it should. Latch moves freely, no visible damage. HUD wire and HUD visor intact, no visible damage. Gasket intact, no apparent damage. Regulator sn visible on body of regulator, the number 60613 is etched on the inside of the locking plate.</p> | |

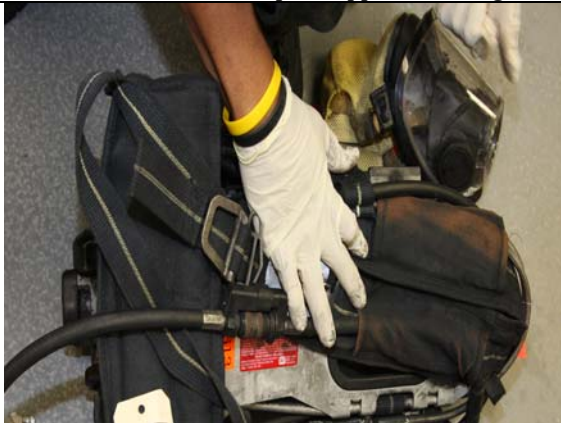
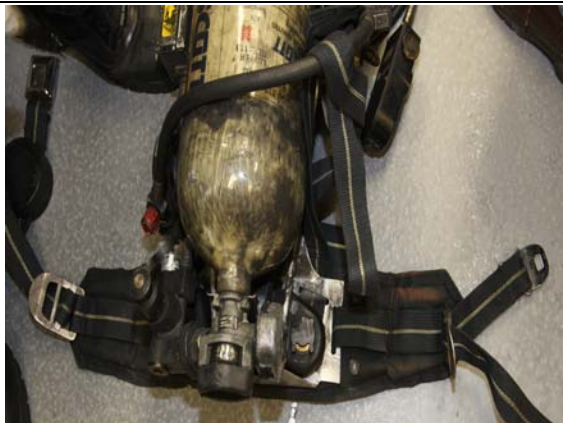
| <p>Female waist strap has regulator holder attached, no apparent damage. Male waist strap no apparent damage, buckles operate normally and lock securely. Cylinder retention strap / buckle locked, no damage. Back part of latch plate slightly blistered.</p> | <p>Adjustable clip for retention strap blistered.</p> |

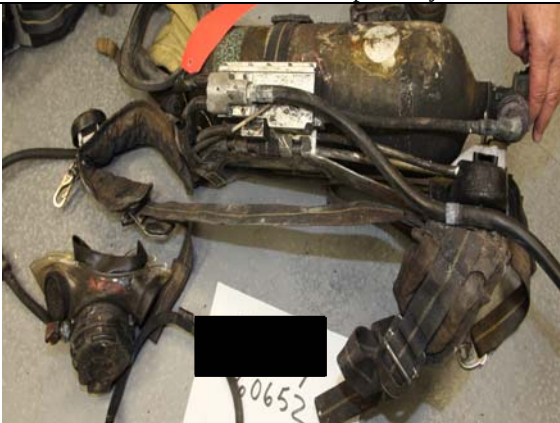
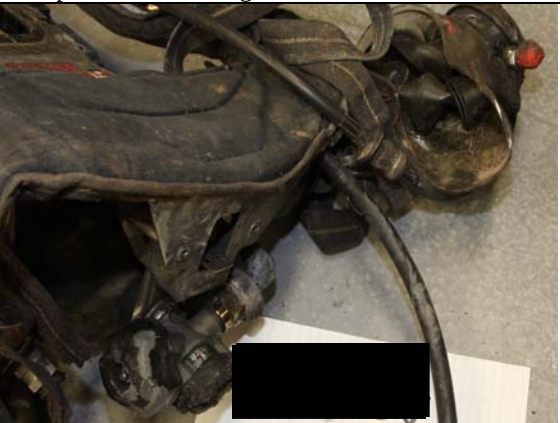
| <p>EBSS hose has a tear in the outer cover at the reducer, some damage to inner weave.</p> | <p>The top portion of the EBSS hose where it would curve at the top portion of the cylinder appears to have heat damage.</p> |

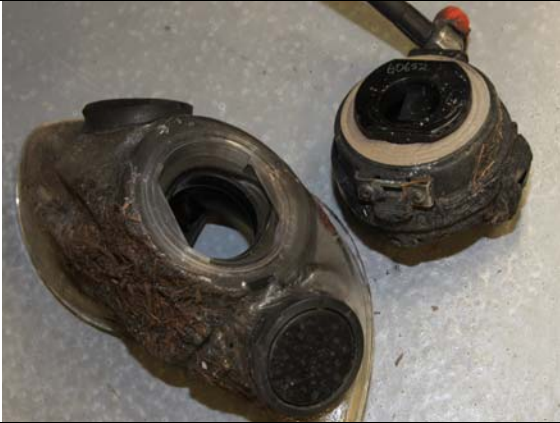
| <p>Regulator body is in good shape, gasket intact, and no damage. Number 10002040 etched onto upper body on purge knob side.</p> | |

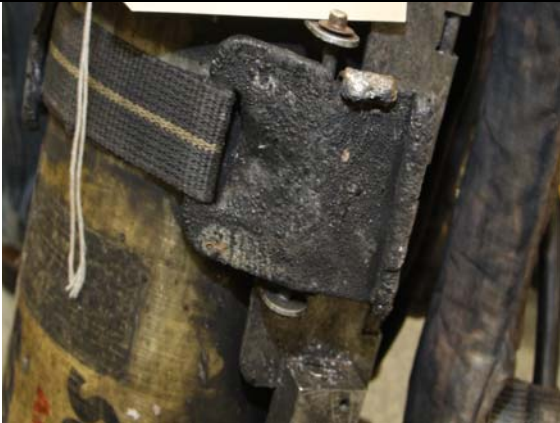
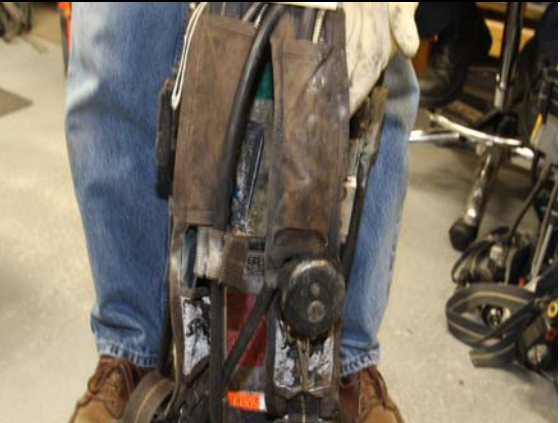
| <p>Gauge retaining strap is cut. Right side of waist to shoulder assembly is cut, some discoloration from heat.</p> | <p>Left side intact; no significant discoloration.</p> |

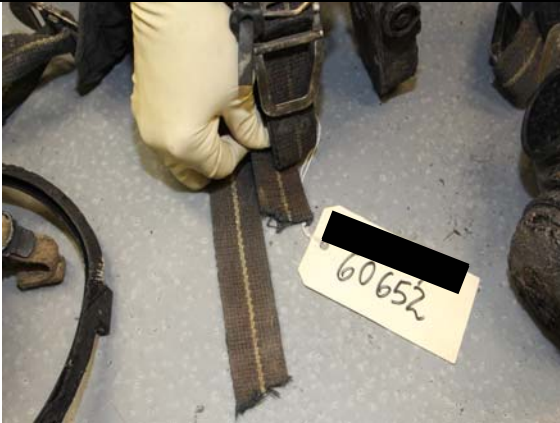
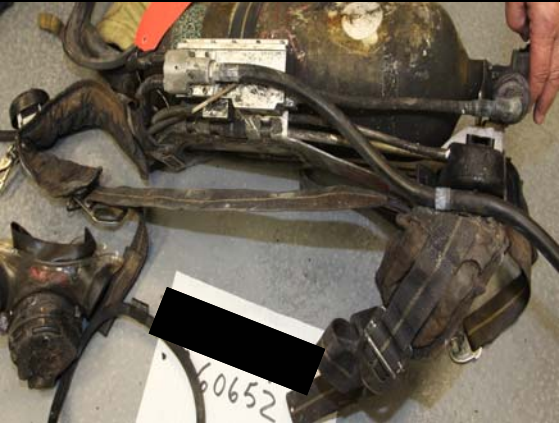
| <p>Waist pad assembly has discoloration; right side has some debris melted on it.</p> | <p>Male waist strap twisted in buckle, no discoloration.</p> |
